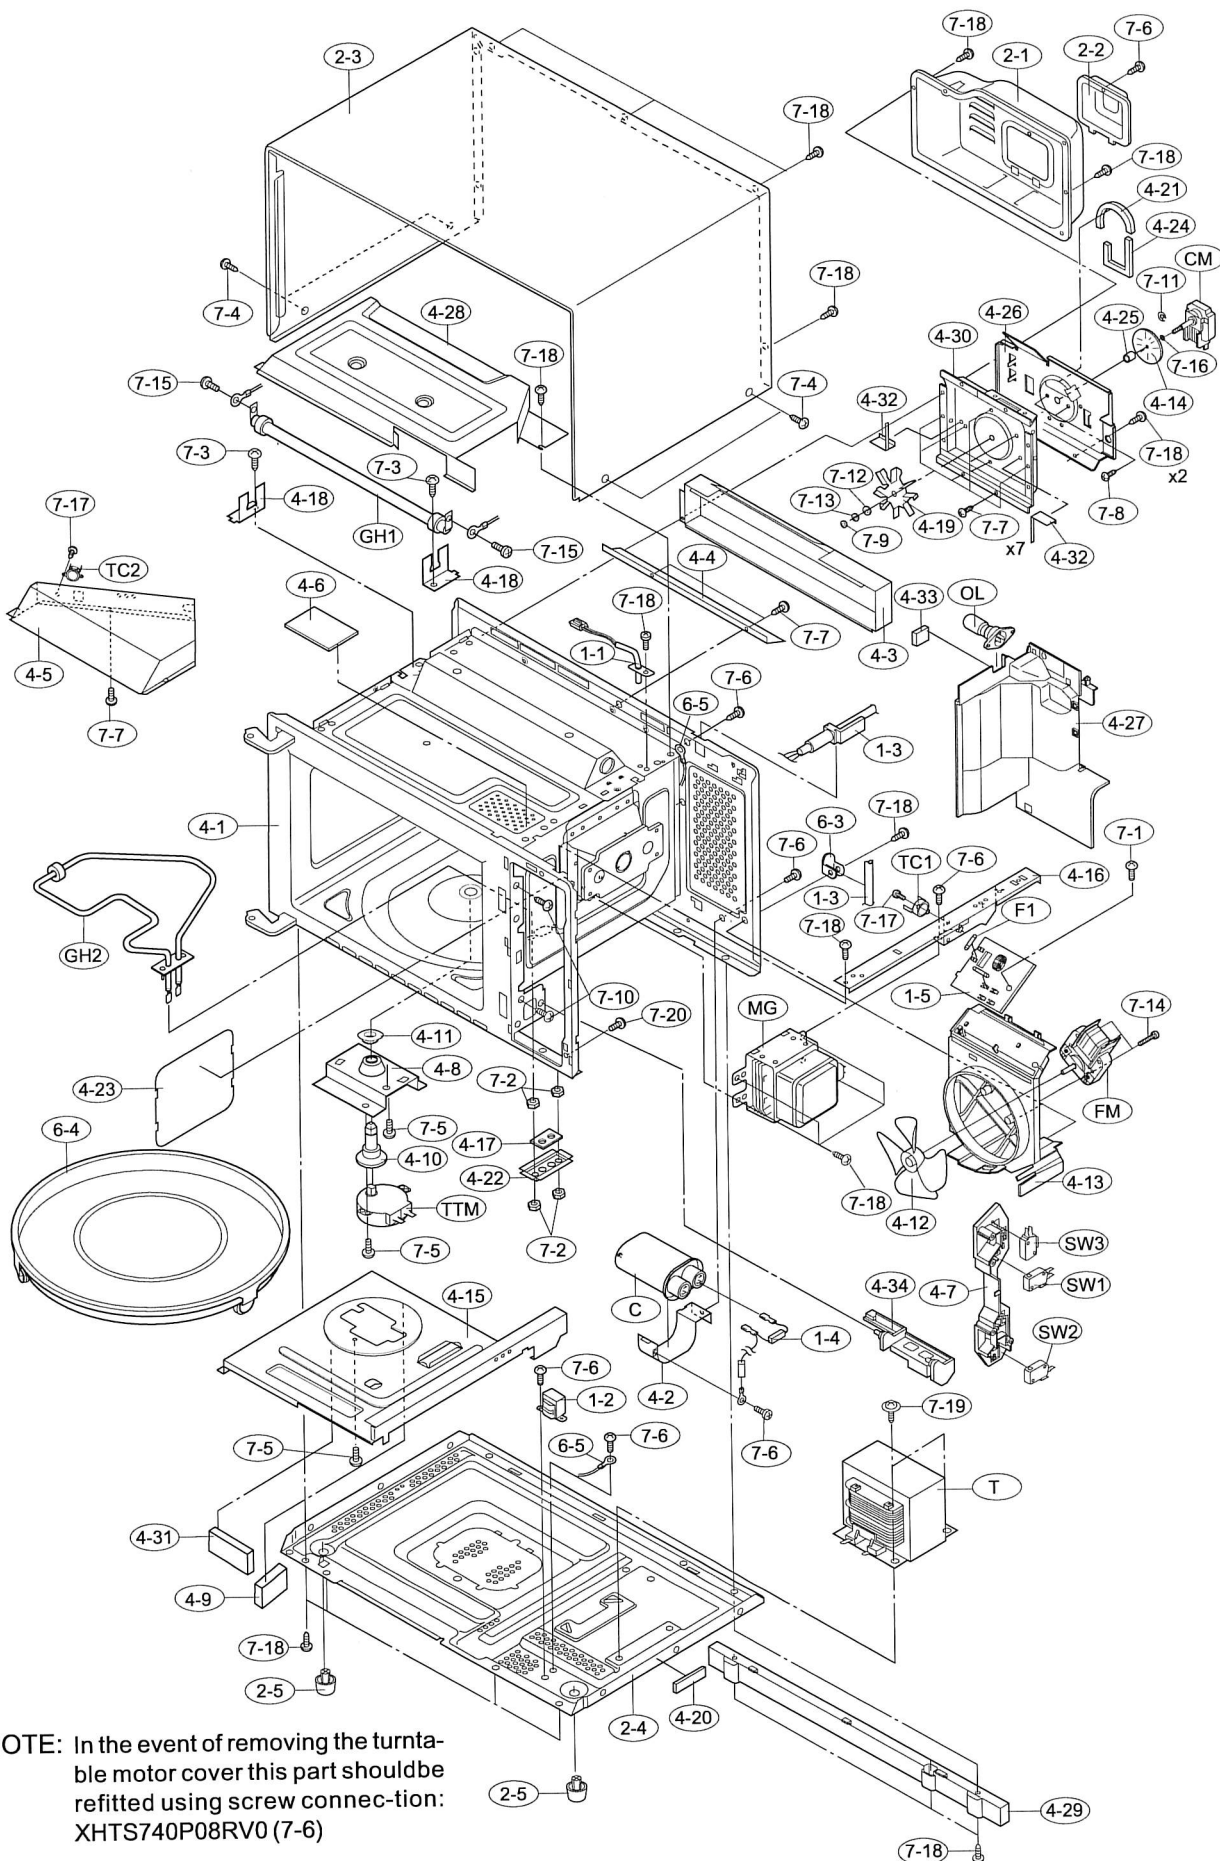
NOTE: In the event of removing the turntable motor cover this part should be refitted using screw connection: XHTS740P08RV0 (7-6)

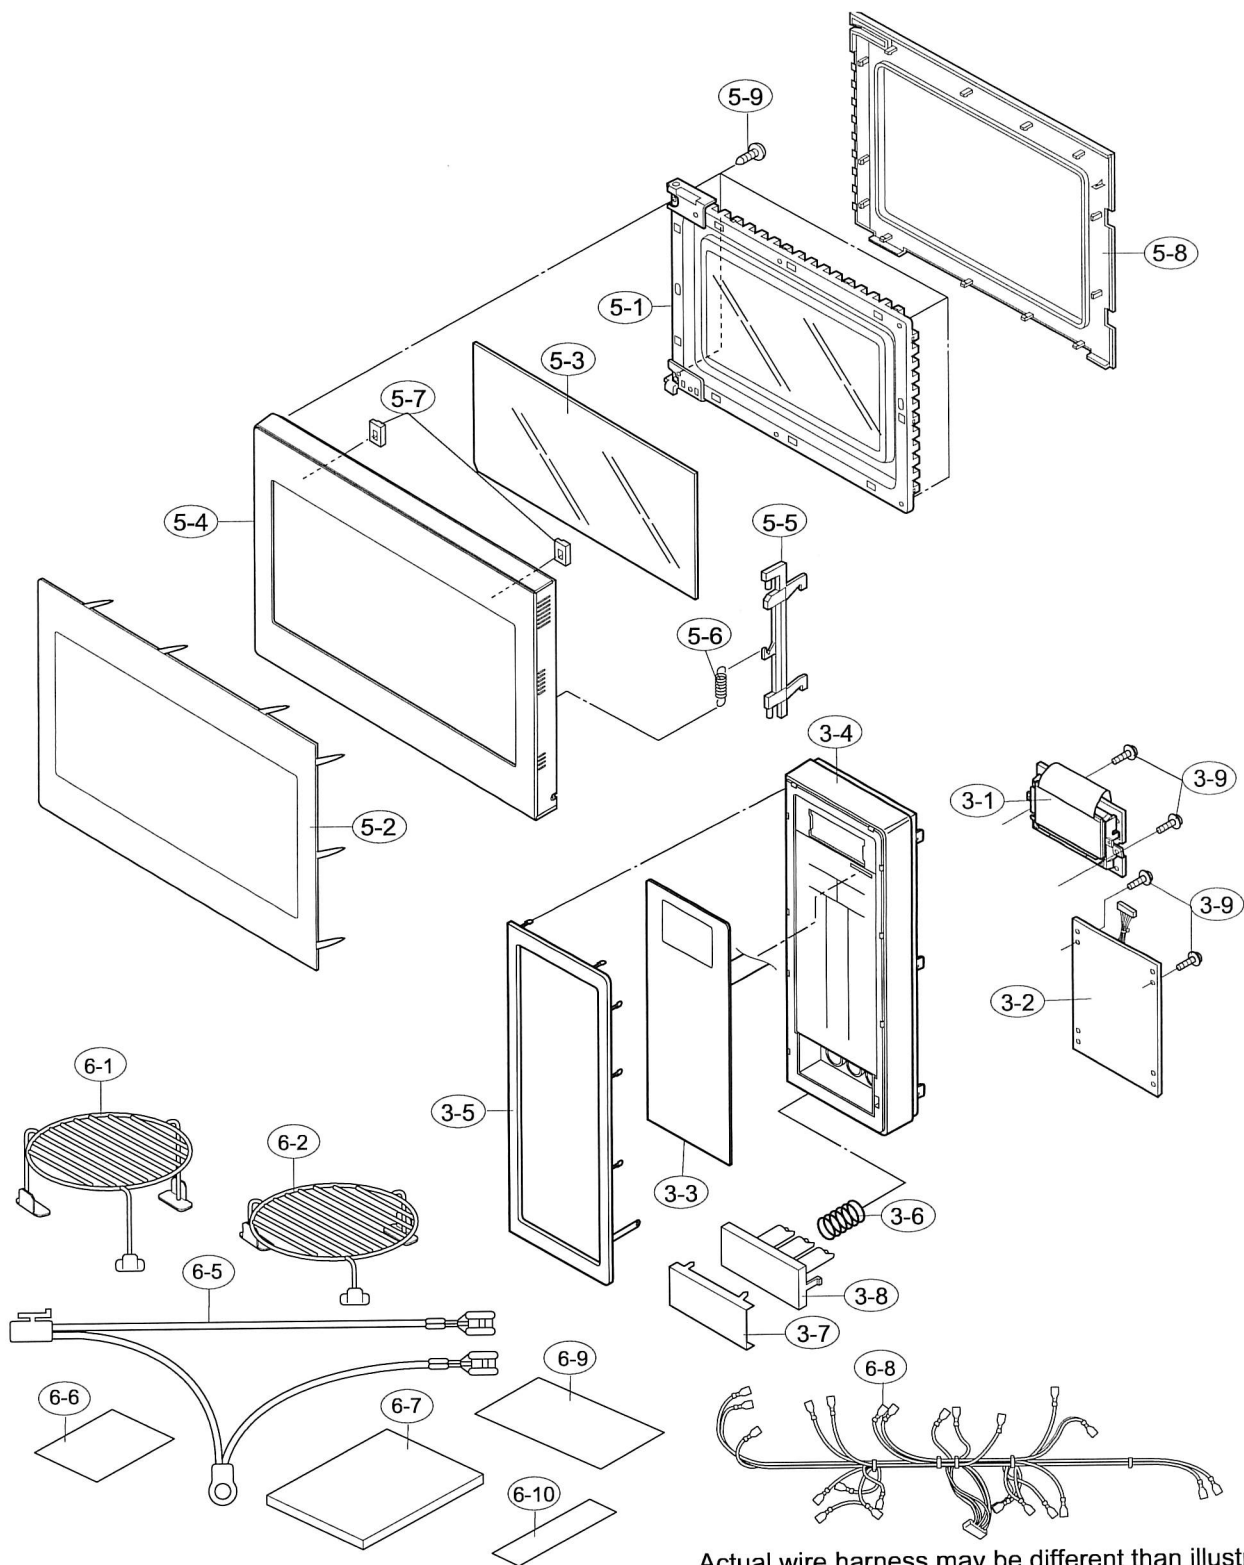
Actual wire harness may be different than illustration.
